## ***Field Advisory A3213R400 3" Threaded Internal Valve***

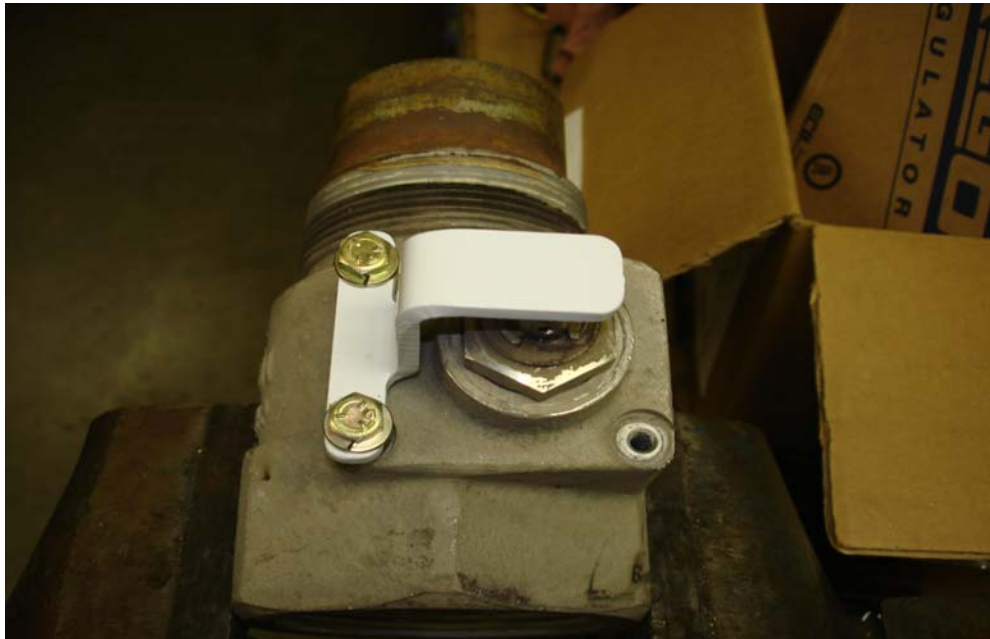
- The photo below shows how the bracket is to be installed on our A3213R400 Series internal valves.

We advise you to immediately install the attached bracket on all of our A3213R400 Series internal valves on the Mississippi Tank trailers. The bracket is designed to prevent the discharge of the pivot shaft in the unlikely event the cam is dislodged this will prevent any discharge of product from the pivot shaft opening.
